RECONSTRUCTING THE IMPACT OF RIVER RESTORATION ON RIVER CONDITION: THE MAYES BROOK

Angela Gurnell and Lucy Shuker

Restoration of the Mayes Brook within Mayesbrook Park

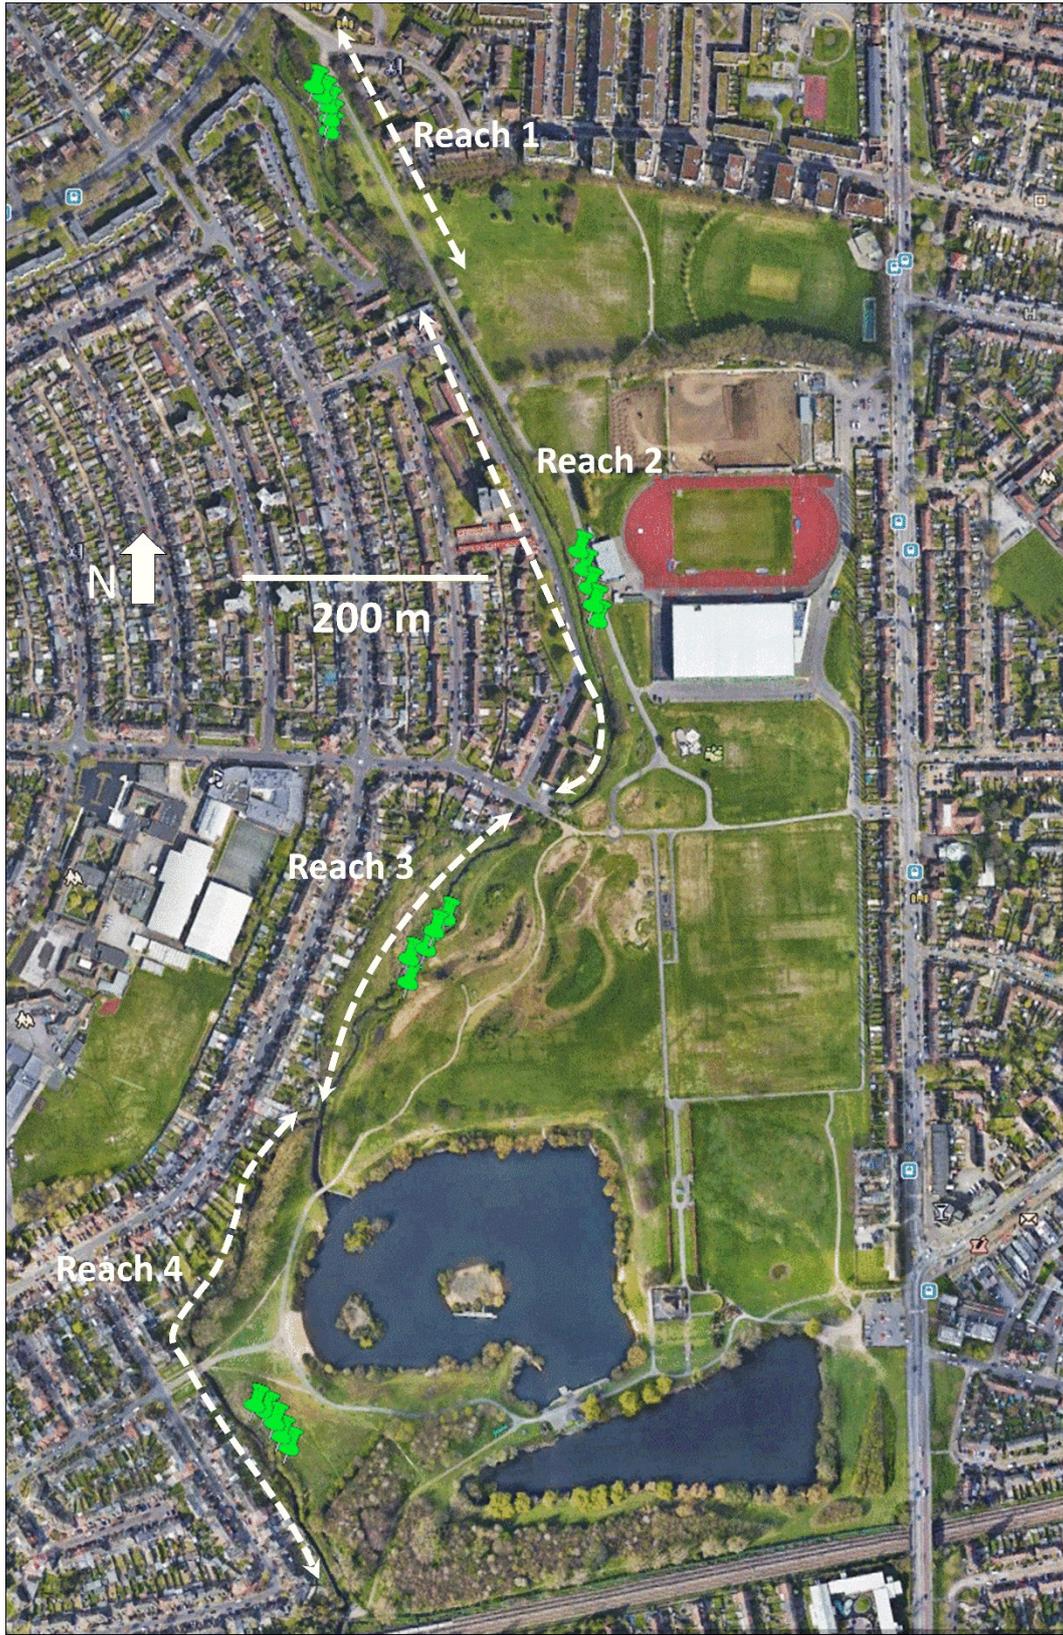
Figure 1: Four reaches (white-dashed lines) of the Mayes Brook, Mayesbrook Park, London, showing the locations of the five MoRPh surveys (green pins) within each of the four MoRPh5 subreaches simulated for the assessment of River Condition (The aerial image is for 03 June 2020 and was drawn from Google Earth (© 2021 Google)).

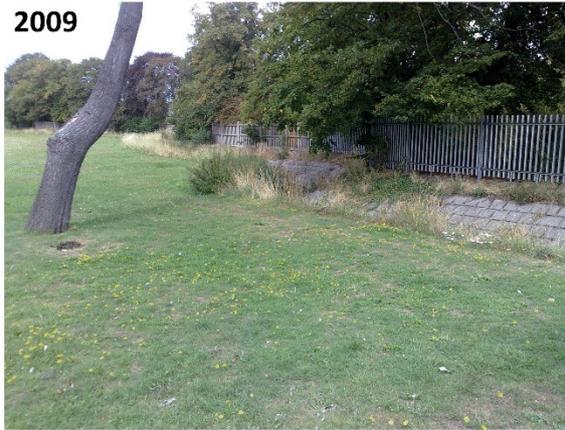
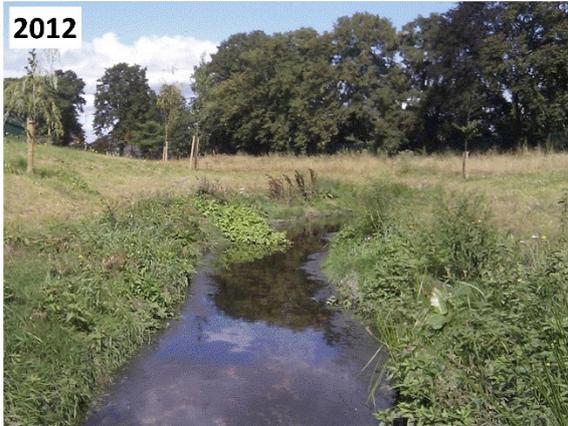
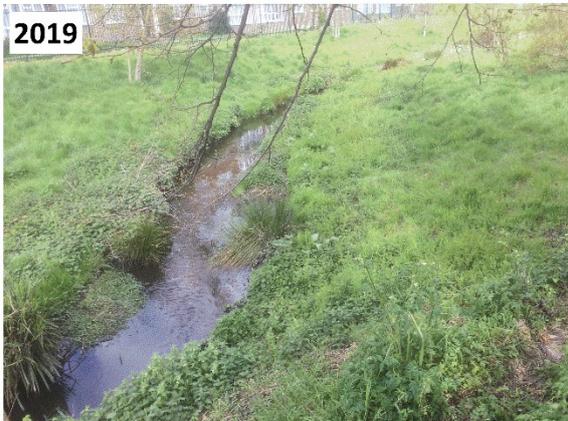
REACH 1

Figure 2: Ground photographs of reaches 1 and 2 close to the MoRPh5 subreach locations and simulated survey dates. Note that in reach 1, the river was moved into a completely new channel during the restoration; all photographs are looking upstream. For reach 2, the 2009 and 2012 photographs are looking upstream, whereas the 2019 photograph is looking downstream.

- (ii) Reach 1 was also transferred from a deep trapezoidal channel into a new, sinuous and more open channel. Table 1 shows that reach 1 has improved in condition from Poor in 2009 to Moderate in 2012 and 2020. Like reach 3, it retains notable negative condition in relation to Condition Indicators E12, E7 and B5.

- (ii) Reach 1 was also transferred from a deep trapezoidal channel into a new, sinuous and more open channel within a fenced nature reserve area.
- (iii) Reach 4 was only restored in its downstream section. The river largely remained in its pre-restoration channel, although planform sinuosity was increased slightly in one location. Where space allowed one bank was reprofiled to give it a lower gradient and to widen the river bed slightly.

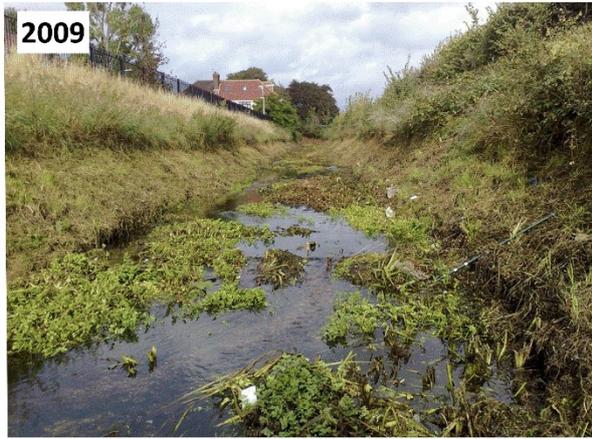
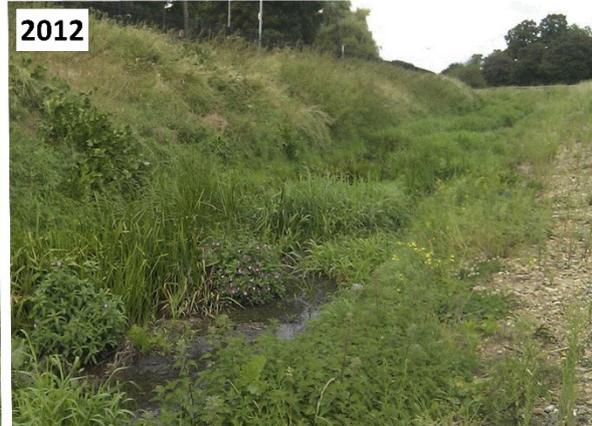
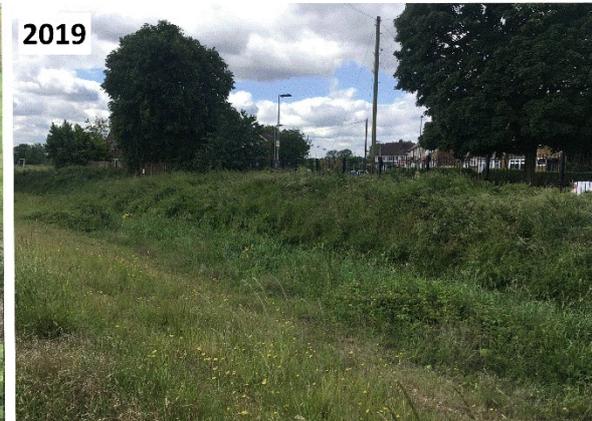
REACH 2

- (iv) Reach 2 received minimal modification during the restoration period and has shown no improvement in condition, rating as Fairly Poor in 2009, 2012 and 2020. It shows the same notable negative condition indicators as reach 4, but it achieves even lower negative Condition Scores.

- (iv) Reach 2 received minimal modification due to underground infrastructure. However, the gradient of one bank was reduced along the majority of the reach.

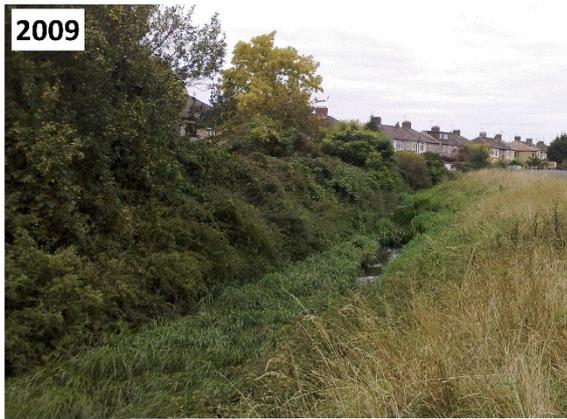
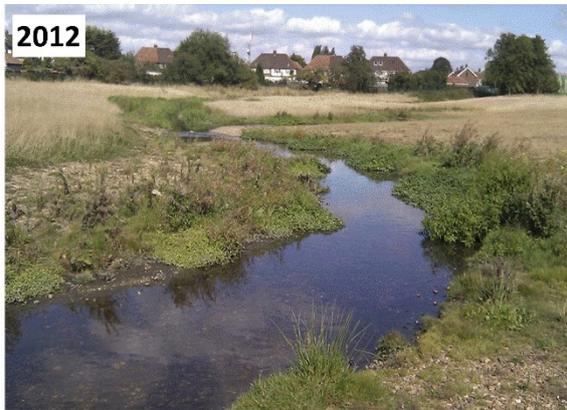
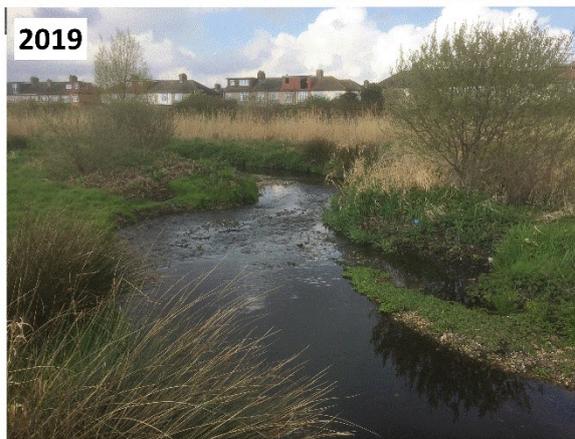
REACH 3

Figure 3: Ground photographs of reaches 3 and 4 close to the MoRPh5 subreaches and simulated survey dates. Note that in reach 3, the river was moved into a completely new channel during the restoration; the photographs for 2009 and 2012 look upstream and the photograph for 2019 looks downstream. For reach 4, all photographs look downstream.

- (i) Reach 3 was subject to the most elaborate restoration with realignment to a new planform and excavated shallow floodplain. Table 1 shows that reach 3 has improved in condition from Fairly Poor in 2009 to Moderate in 2012 to Fairly Good in 2020. The main negative indicators that continue to depress its condition are filamentous algae (Condition Indicator (E12) suggesting poor water quality), superficial bed siltation (E7) and bank top managed ground cover (B5).

- (i) Reach 3 was subject to the most elaborate restoration. Here, the floodplain was lowered to create 1 hectare of additional flood storage and the river was moved from its trapezoidal channel at the margin of the park into a new, more open, sinuous channel at the centre of the lowered area, with connections at moderate flow to newly created disconnected floodplain ponds. A new connected wetland pond was constructed in the location of the old channel to intercept flows entering the river from a storm sewer.

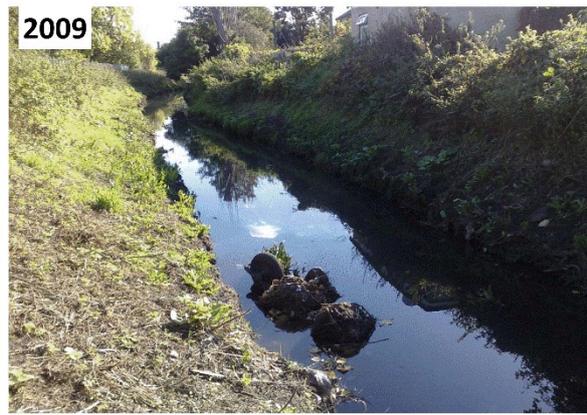
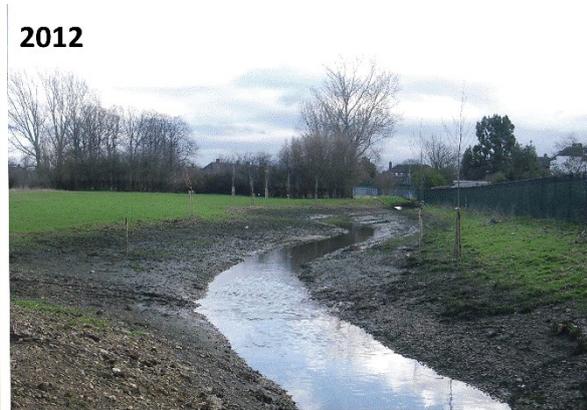
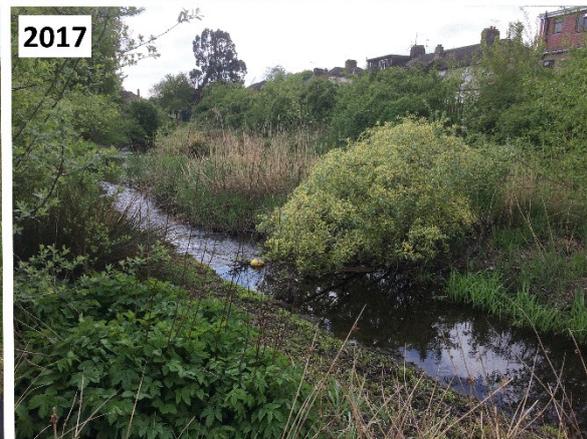
REACH 4

- (iii) Reach 4 was only restored in its downstream section and this was where the simulated MoRPh5 surveys were located. Table 1 shows that this part of reach 4 did not improve from Fairly Poor in 2009 to 2012 (although the preliminary condition score increased) but has recently improved to Moderate in 2020. Like reaches 1 and 3, it retains notable negative scores for Condition Indicators E12, E7 and B5 but it also has poor scores for the extent of artificial bank profiles (C7).
