EVALUATING THE IMPACT OF RESTORATION USING LARGE WOOD ON THE BEVERLEY BROOK, WIMBLEDON COMMON, LONDON

Angela Gurnell¹, Lucy Shuker^{2,3}, Toby Hull⁴

¹ Queen Mary University of London ² Cartographer, ³ Thames 21, ⁴ South East Rivers Trust / Wandle Trust

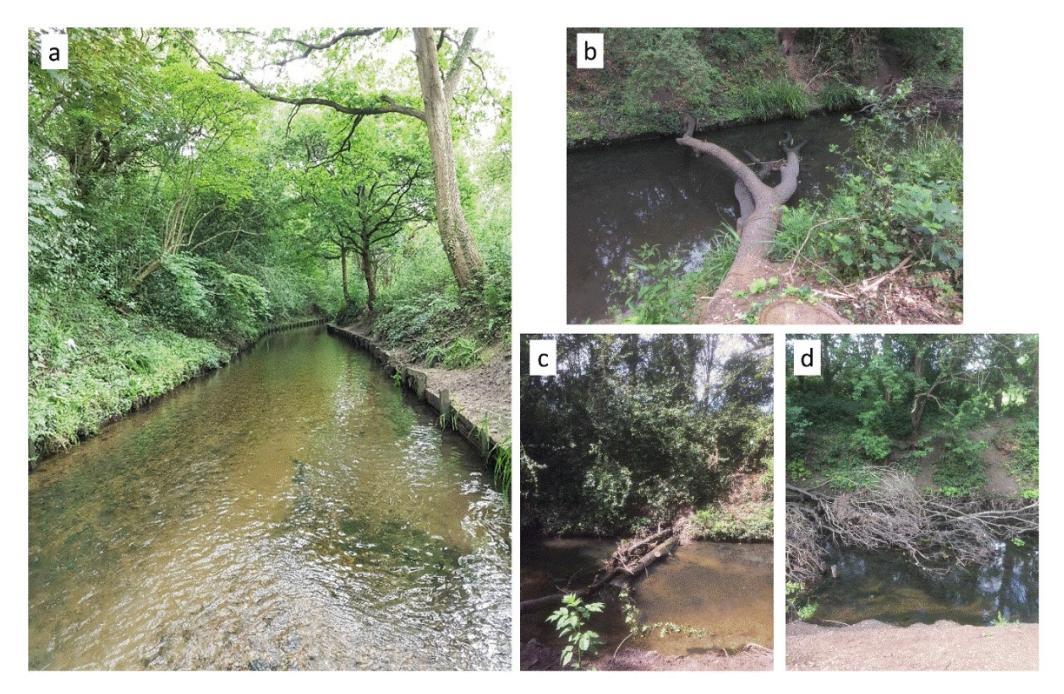
The restoration was implemented early in 2019. Figure 1a shows a typical view of the river prior to restoration. While the banks are well vegetated and support mature trees, they have relatively smooth profiles and are very high. This coupled with the wide river bed suggests historical 'channelisation' of the river many decades ago with subsequent slow morphological recovery under vegetation colonisation to produce the current semi-natural woodland cover. Although the river has a gravel bed, much of the gravel is buried below layers of fine sand and silt, and much of silt has a high organic content.

Figure 1: (a). the river prior to restoration. The three types of wood introduced during restoration: trees (b), large logs, trunks or stumps (c), brash, branches, small logs (d).

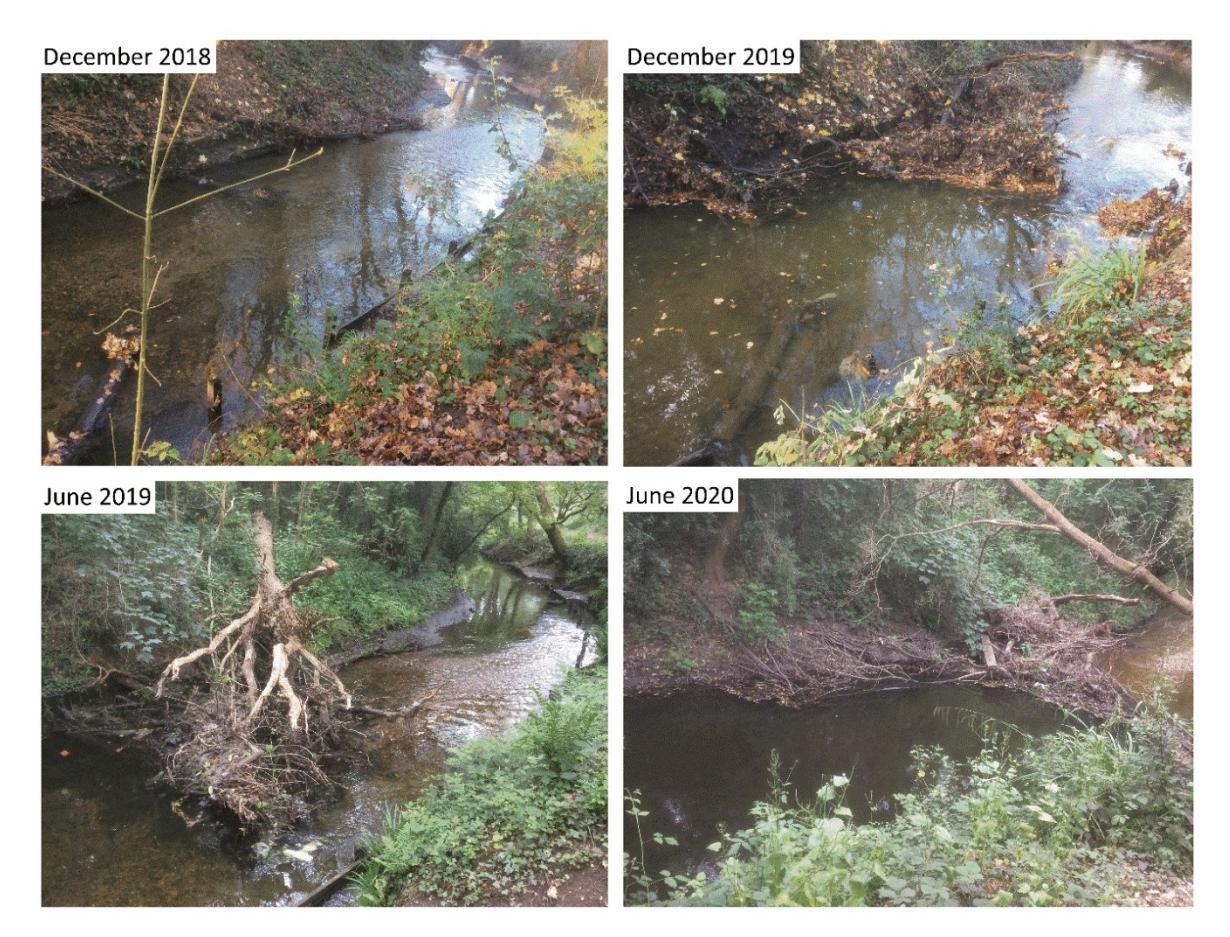
However, a tree that fell into subreach A2 (at the junction between modules 4 and 5) had a far stronger impact on the river bed than that at the junction between the two control reaches. Figure 6 illustrates the tree's location taken looking downstream from approximately the same position on each monitoring date. In December 2018, there was a small fallen, heavily decayed tree aligned along the toe of the left bank. Between December 2018 and June 2019, a large tree fell diagonally across the river, covering the pre-existing smaller tree and touching the river bed. By June 2019, this tree was already trapping organic material including small wood pieces and had induced the development of a scour pool towards the right bank and gravel bar on the downstream river bed. Higher water levels disguise some of these bed features in the December 2019 photograph but more wood and organic material had accumulated around the fallen tree. By June 2020, following further trapping of wood and organic material, a major pool was ponded upstream of the tree, a scour pool was present towards the right bank and immediately downstream of the tree, with a large gravel bar further downstream (the bar is just visible on the right side of the June 2020 photograph, Figure 6). These changes are typical consequences of natural tree fall. The complex and rapid rate of change in the channel form results not only from the

presence of the tree but also the fact that it is not tethered and so has been able to move both laterally and vertically as it interacts with different flow events.

Figure 6: Changes in the presence of wood and organic material and in the morphology of the river bed at a site in control subreach A2 before and after natural tree fall.

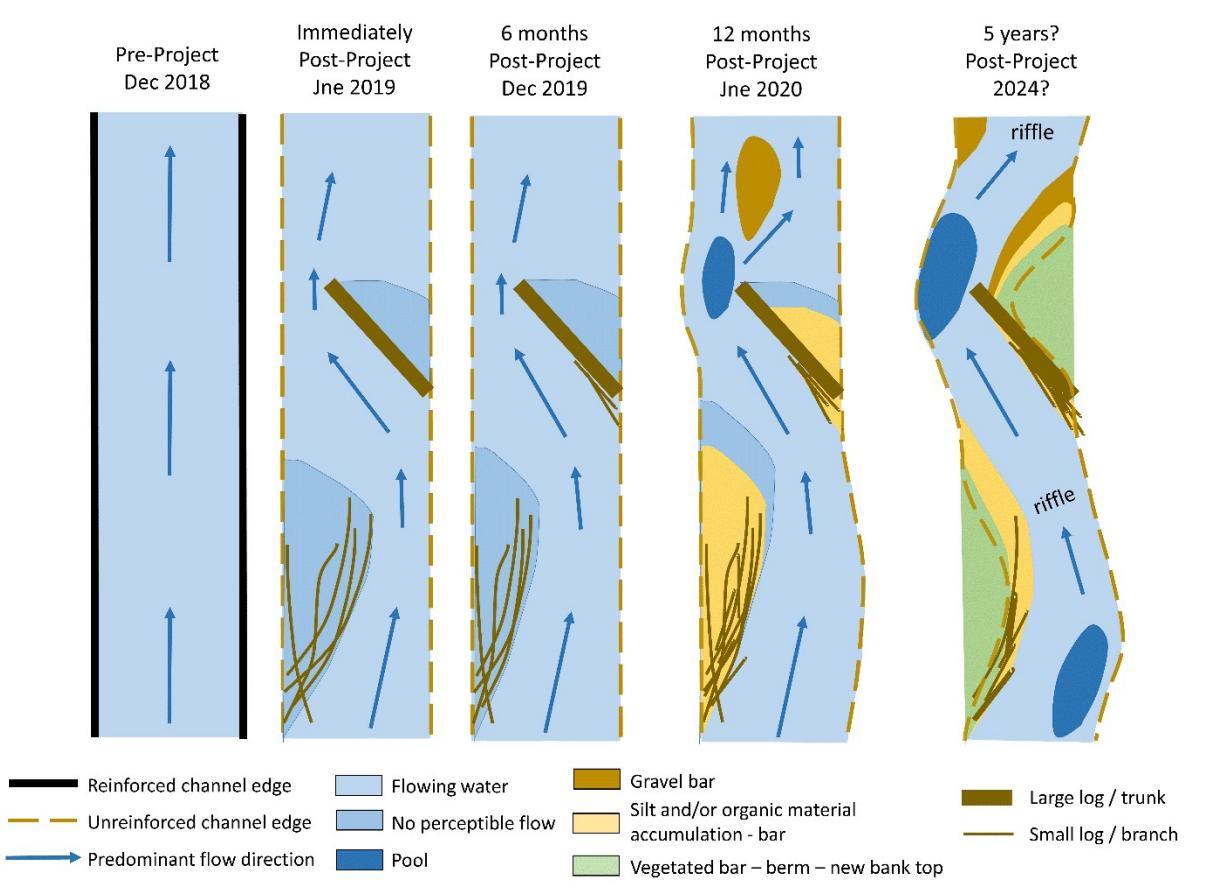
Figure 7: Visualisation of how the river has responded to restoration actions over the monitoring period and how it may continue to respond in the future.

Figure 7 also visualises how the river may continue to evolve over the next 5 to 10 years. Bed scour and pool development is likely to continue in parallel with the development of side bars and backwaters (recesses in the bank line). As the side bars aggrade and transition from unvegetated to vegetated bars and then in some cases to berms, benches and eventually extensions of the river bank, the channel will narrow. A narrowing channel will induce faster flow velocities, particularly across wood-free areas of the bed, and as a result the mobilisation of gravel to produce distinct gravel riffles and bars. If the channel narrowing also promotes significant bank erosion, particularly opposite developing bars, berms and benches, the channel will become sinuous and trees on the eroding banks will fall into the channel.
