EVALUATING THE IMPACT OF RESTORATION USING LARGE WOOD ON THE BEVERLEY BROOK, WIMBLEDON COMMON, LONDON

Angela Gurnell¹, Lucy Shuker^{2,3}, Toby Hull⁴

¹ Queen Mary University of London ² Cartographer, ³ Thames 21, ⁴ South East Rivers Trust / Wandle Trust

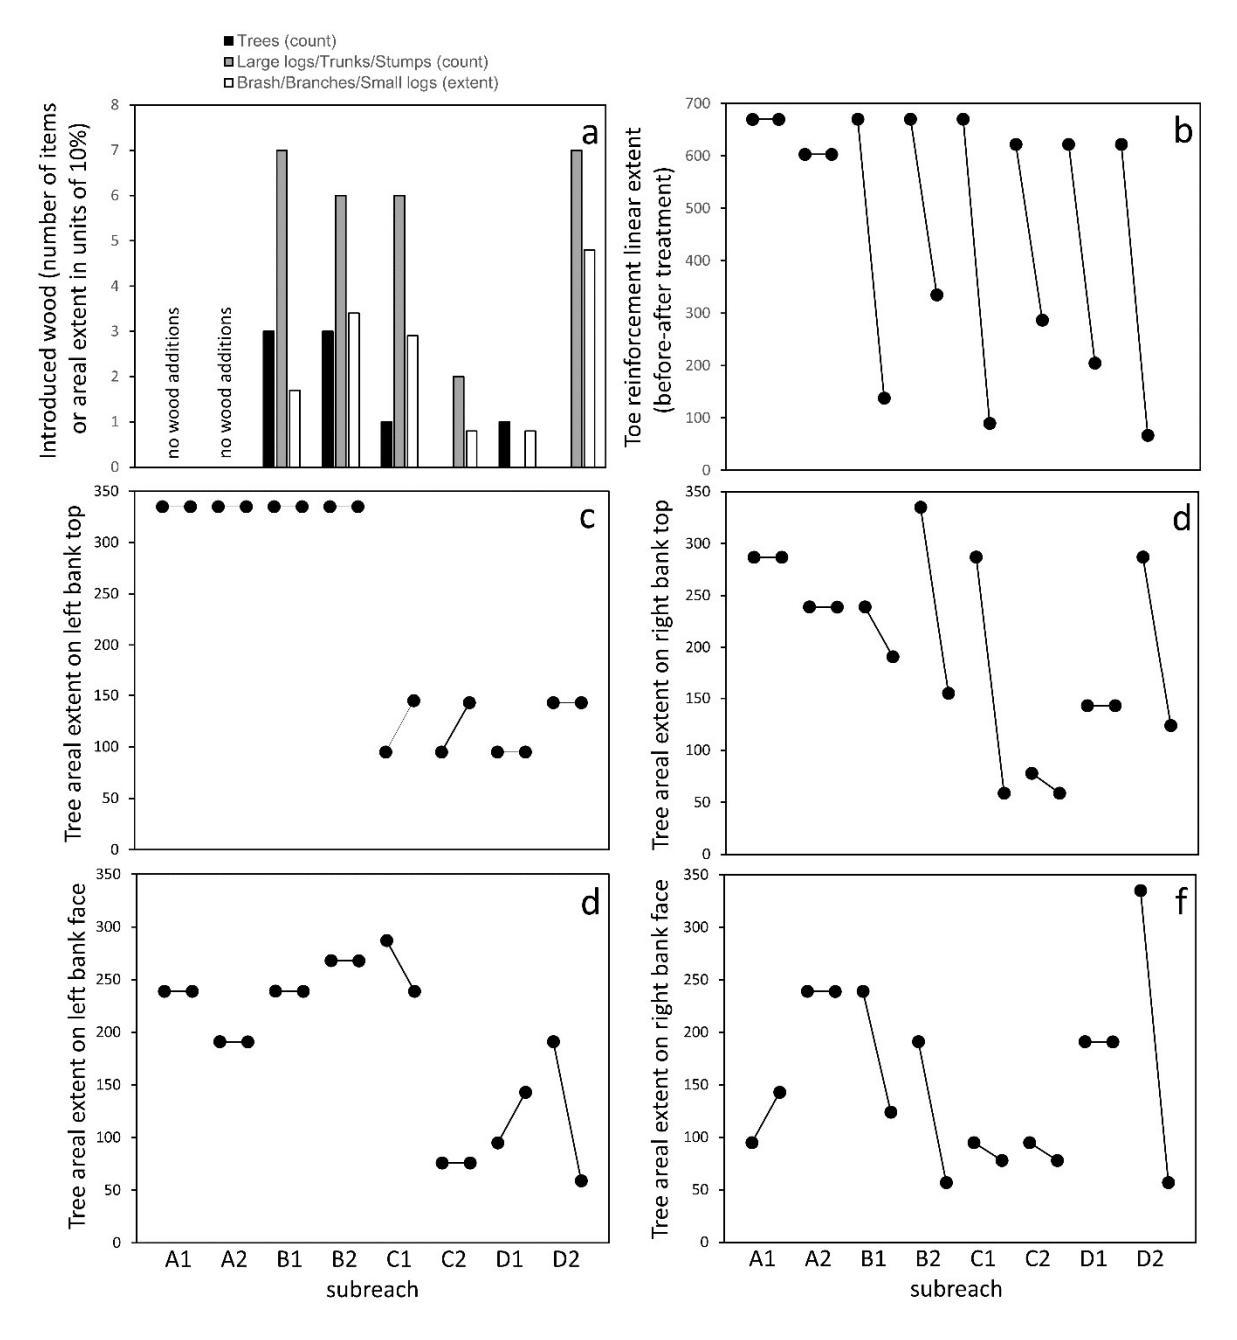
Figure 3: A summary of river restoration actions (observed changes between the preproject survey in December 2018 and the first post-project survey in June 2019):

Introduction of wood to the river channel bed, varied in both its type and also its number or areal extent across the 6 treatment subreaches (Figure 3a). No wood was deliberately introduced into the control subreaches (A1, A2). The greatest variety in both the types and quantity of introduced wood was observed in subreaches B1 and B2. Subreaches C1 and D2 received less wood than B1 and B2, and whereas C1 received all three types of wood, no trees were added to subreach D2. Only quite small amounts and a restricted range of types of wood were introduced into subreaches C2 and D1. Note that in Figure 3a, trees and large logs/trunks/stumps are recorded as a count across the 5 MoRPh surveys, whereas brash/branches/small logs are recorded in units of 10% areal extent across the river bed (i.e. a potential range of 0 to 10).

The second restoration action was the removal of toe reinforcement from both banks within a potential numerical range of 0 to 335 on each bank and thus 670 for both banks (Figure 3b). The linear extent of toe reinforcement in the control subreaches (A1, A2) is very high and remains unchanged, whereas there are major reductions in the linear extent of reinforcement in all the treatment subreaches (all observed reductions exceed 134 and thus show > 20% change within the potential 0 to 670 range), with almost complete removal of toe reinforcement along subreaches B1, C1 and D2.

The third restoration action was tree felling, which provided the wood for introduction into the river. Figures 3 c, d, e, f compare the areal extent of trees on each river bank top and bank face before and after the restoration The only notable reduction in tree cover on the exceeding 67) changes were observed. However, the right bank shows notable reductions in tree cover on the bank top (Figure 3d, subreaches B2, C1 and D2) and bank face (Figure 3f, subreaches B1, B2, D2) and no other notable changes whether positive or negative.

a. the amount and types (whole trees, large logs-trunks-stumps, brash-branches-small logs) of wood added to the subreaches (note that where the vertical axis refers to brash-branches-small logs, it is expressed in units of approximately 10% cover of the river bed)

Treatment subreaches B1, B2, C1 and D2 received the most wood and showed the greatest corresponding reduction in bank tree cover, particularly on the right bank. All treatment subreaches experienced over 50% removal of toe reinforcement, with B1, C1 and D2 experiencing close to 100% removal (Figure 3).

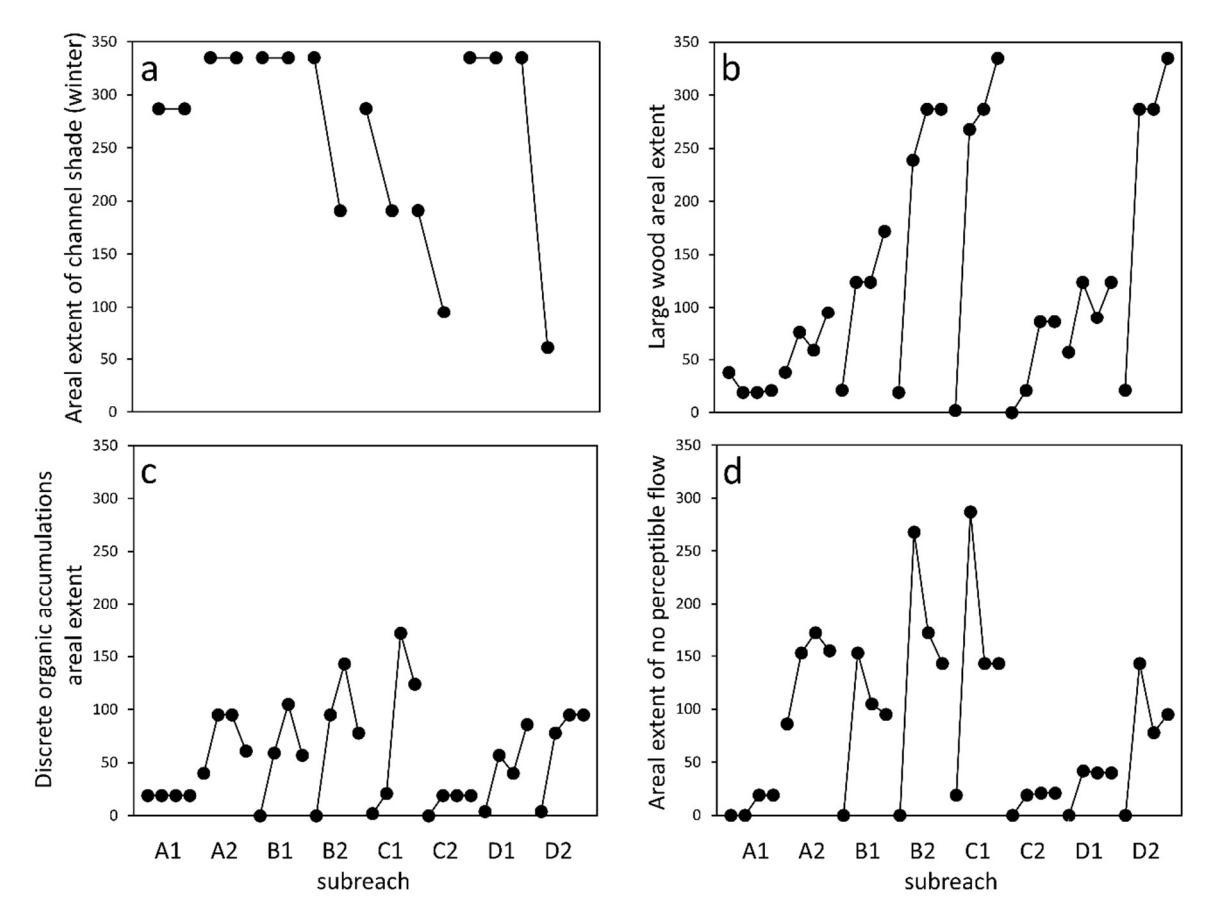
Figure 4: Direct consequences of restoration actions:

Direct effects of the restoration actions are illustrated in Figure 4. Changes in shading of the channel are illustrated by comparing winter pre-project (December 2018) and post project (December 2019) conditions (Figure 4a). There were notable reductions in shade within subreaches B2, C1, C2 and D2, reflecting tree felling. Notable increases in the areal extent of wood are observed as wood is introduced between the first two surveys (December 2018, June 2019), particularly in subreaches B1, B2, C1 and D2, with further consistent but small increases in all the treatment subreaches as additional (mobile) wood pieces are trapped in the following two surveys (December 2019, June 2020) (Figure 4b). There is also close to a 20% increase in the areal extent of wood retained in control subreach A2 over the observation period as a result of natural wood input processes. In addition to these larger wood pieces, discrete organic accumulations comprised largely of leaves and twigs increase consistently in all treatment subreaches and one control subreach (A2) through the two year observation period, with notable increases in subreaches B1, B2, C1, D1 and D2 (Figure 4c). The introduced wood slows local water flow velocities, leading to consistent increases in the areal extent of no perceptible flow immediately post restoration (Figure 4d, June 2019) followed by either no change or a slight reduction as the wood settles and becomes more streamlined over the last two observation periods (December 2019, June 2020). These reductions in the area of no perceptible flow are notable (> 67) in treatment subreaches B1, B2, C1 and D2. In addition there is a smaller but still sizeable increase in the area of no perceptible flow in control subreach A2. These changes are summarised in Table 2

a. change in the areal extent (maximum possible value 335) of channel shading in winter between the first survey (pre-project - December 2018) and the third survey (post-project - December 2019)

reduced flow velocities across the affected areas of the river bed and resulted in an increase in the area with no perceptible flow (Figure 4d). While the MoRPh surveys were conducted during periods of relatively low flow, the effects of the accumulations of wood and organic material during higher flows would have been to increase flow velocities across the woodfree areas of the river bed. These hydraulic impacts of the wood and organic material can explain the increase in the area of the bed under thick or continuous superficial silt. Silt being transported by the river is likely to move from areas of higher velocity into the areas of lower flow velocity covered by wood and organic material and to accumulate there. This explains the appearance of unvegetated silt side bars towards the end of the observation period as the silt has built up beneath the wood and organic material. In addition, areas of the bed unaffected by wood and organic material are likely to be subject to relatively higher flow velocities, leading to the scouring of pools in the river bed and the erosion of the toes of banks exposed by reinforcement removal. Such bank scour produces marginal backwaters or embayments at the channel edge. Although erosion of the bed is occurring, as evidenced by pool development, this is not leading to a notable increase in the exposure of bed gravel. This is explained by the input of substantial amounts of silt from bank scour. Figure 7 visualises how the river has changed as the result of the described responses to the restoration actions.

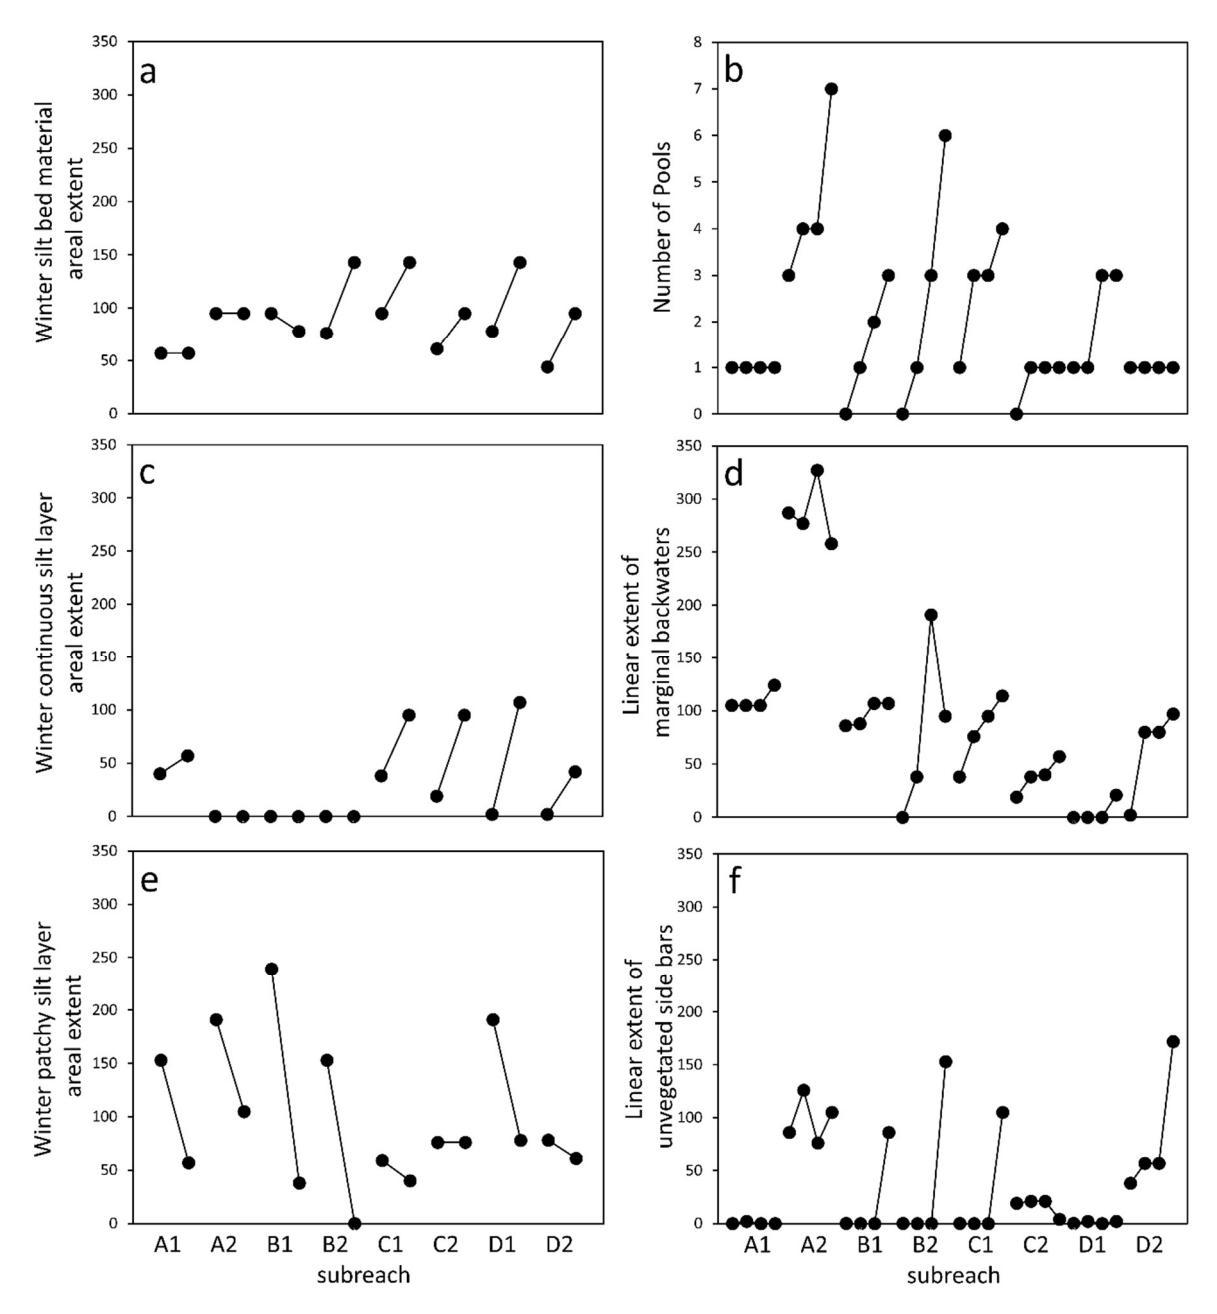
Figure 5: Secondary consequences of restoration actions:

Sedimentary consequences of the restoration actions are expressed mainly by the silt cover on the river bed (Figure 5 a, b, c). To remove seasonal variations in bed condition, these changes are illustrated by comparing the pre-project (December 2018) and post project (December 2019) winter observations. The data shows consistent but modest increases in the area of the bed covered by substantial thicknesses of silt in five of the treatment subreaches (B2, C1, C2, D1, D2, Figure 5a), and the area of the bed covered by a continuous superficial layer of silt in four of the treatment subreaches (C1, C2, D1, D2, Figure 5c). At the same time, there are notable decreases in the area of the bed covered by a discontinuous, superficial layer of silt in both control subreaches and three of the treatment subreaches (A1, A2, B1, B2, D1, Figure 5e).

Three main morphological changes were observed. First, a consistent increase was observed in the number of pools in 5 of the treatment subreaches (Figure 5b, 0 to 3 pools in subreach B1, 0 to 6 in B2, 1 to 4 in C1, 0 to 1 in C2, 1 to 3 in D1) but there was also an increase from 3 to 7 in control subreach A2. Second, the linear extent of marginal backwaters (embayments at the bank toe) showed a notable increase in treatment subreaches B2, C1 and D2 (Figure 5d). This takes account of the fact that although such backwaters could occur on opposing banks (theoretical maximum range 0 to 670), in practise they tend to occur on only one bank (realistic maximum range of 0 to 335). Lastly, four of the treatment subreaches (B1, B2, C1, D2, Figure 5f) showed a notable appearance (B1, B2, C1) or increase (D2) in the

linear extent of unvegetated side bars between the third and fourth surveys. These changes are summarised in Table 3

a, c, e. changes in the areal extent (maximum possible value 335) of thick silt bed material (a), continuous silt (c) patchy silt (e) overlying coarser material from the first survey (preproject - December 2018) to the third survey (post-project - December 2019)

number of pools (Figure 5) and the mobilisation of the gravel bed to produce a ponded pool, a scour pool and a gravel bar (Figure 6) and a riffle downstream (not visible in Figure 6).
